#### Site 245 Clark Pond

# **Great Marsh Coastal Wetlands Restoration Planning**

Site # 245 Clark Pond

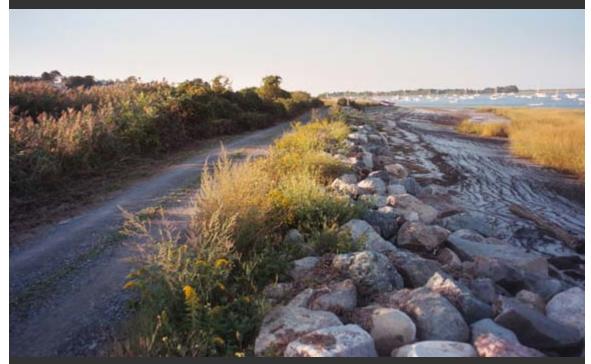
## Photo 1 - Beach Parking Access Road

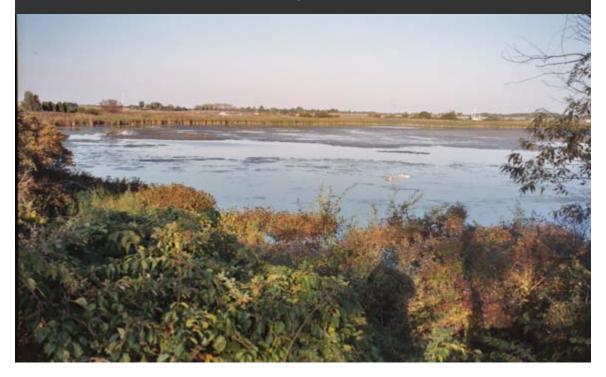
Photo 2 - Northern End of Pond Viewing North

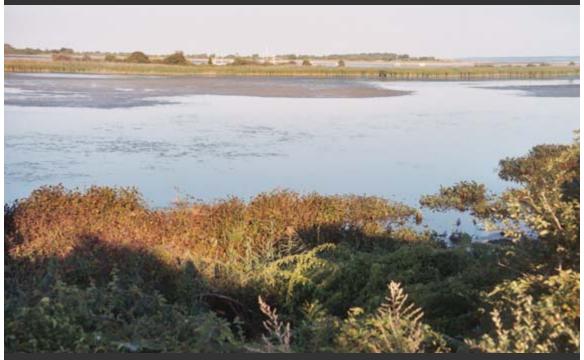
**Photo 3 - Central Portion On Pond East**

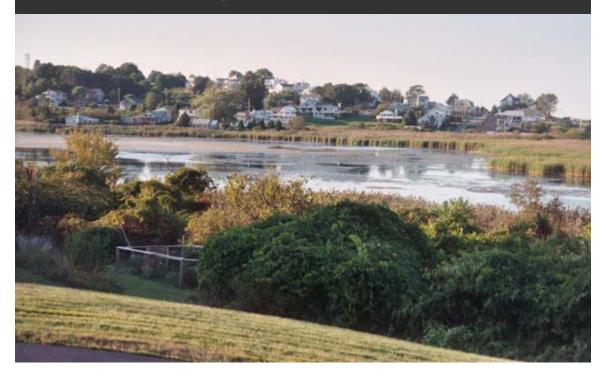
**Photo 4 - Clark Pond Viewing North**

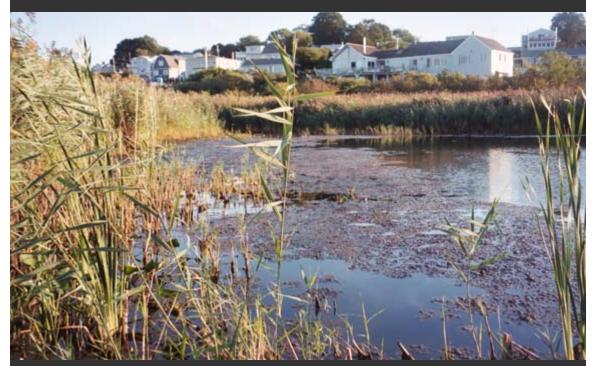
## **Photo 5 - Southern End of Pond**

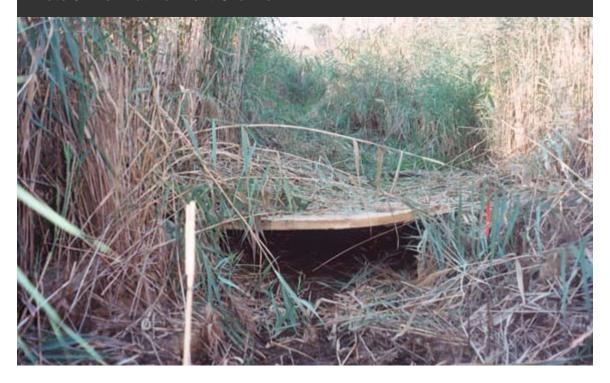
**Photo 6 - Berm at Remnant Channel**

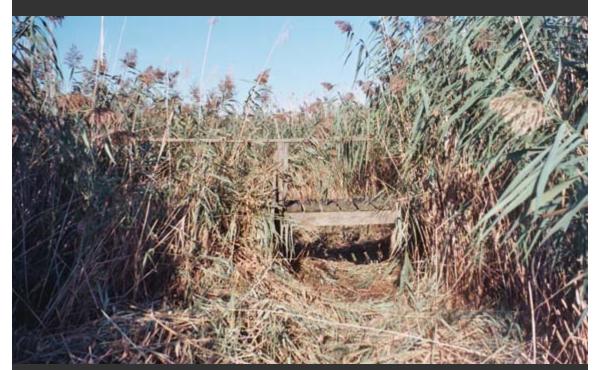
**Photo 7 - Boardwalk Over Remnant Channel**

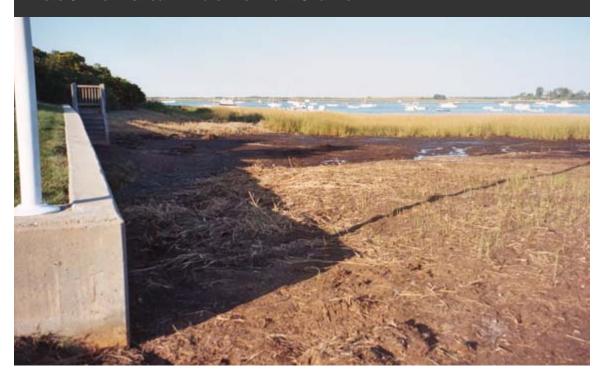
**Photo 8 - Downstream End of Remnant Channel**

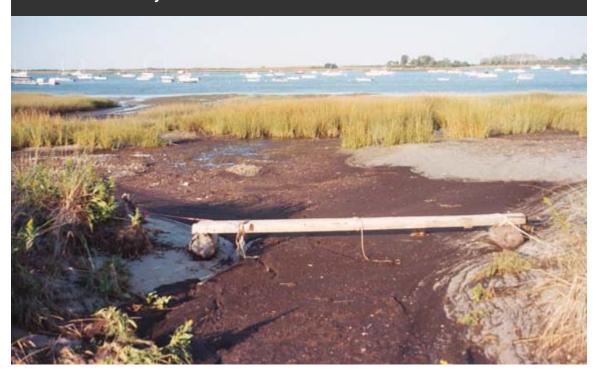
## Photo 9 - Secondary Channel from Pond
